NONDESTRUCTIVE EVALUATIONS OF COM-
POSITE HEATSHIELD MATERIALS BEFORE
AND AFTER AN UNDERGROUND NUCLEAR
EXPOSURE

Southern Research Institute

Air Force Weapons Laboratory

AFWL-TR-73-247

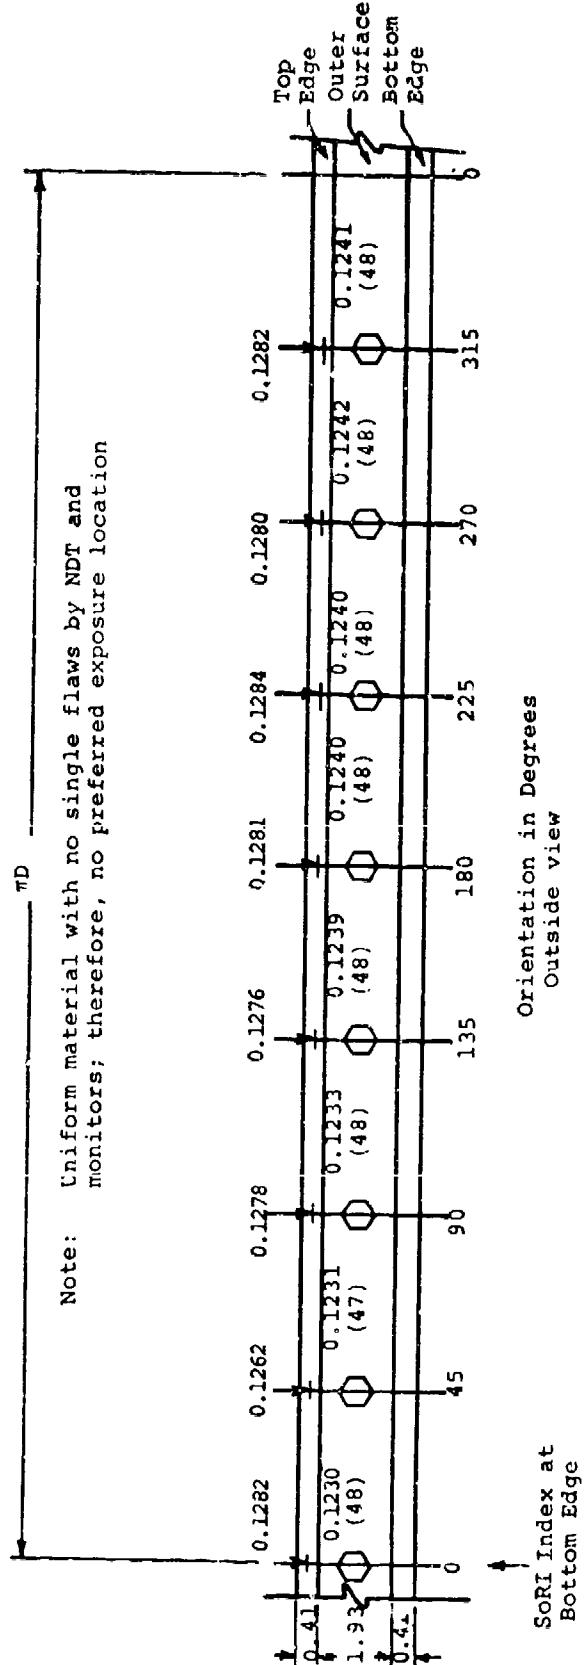
Figure 11. Sketch Showing Inspection Results on Ring 83301-400 from AVCO R6300

1. \bigcirc Radial Velocity in in./ μ sec
(Relative Radial Transmission in added dB) - Higher readings correlate lower attenuative material
2. + Axial Velocity in in./ μ sec
3. Visual and penetrant inspection revealed no flaws
4. Radiography revealed uniform material with no single flaws
5. Density = 1.339 gm/cm³

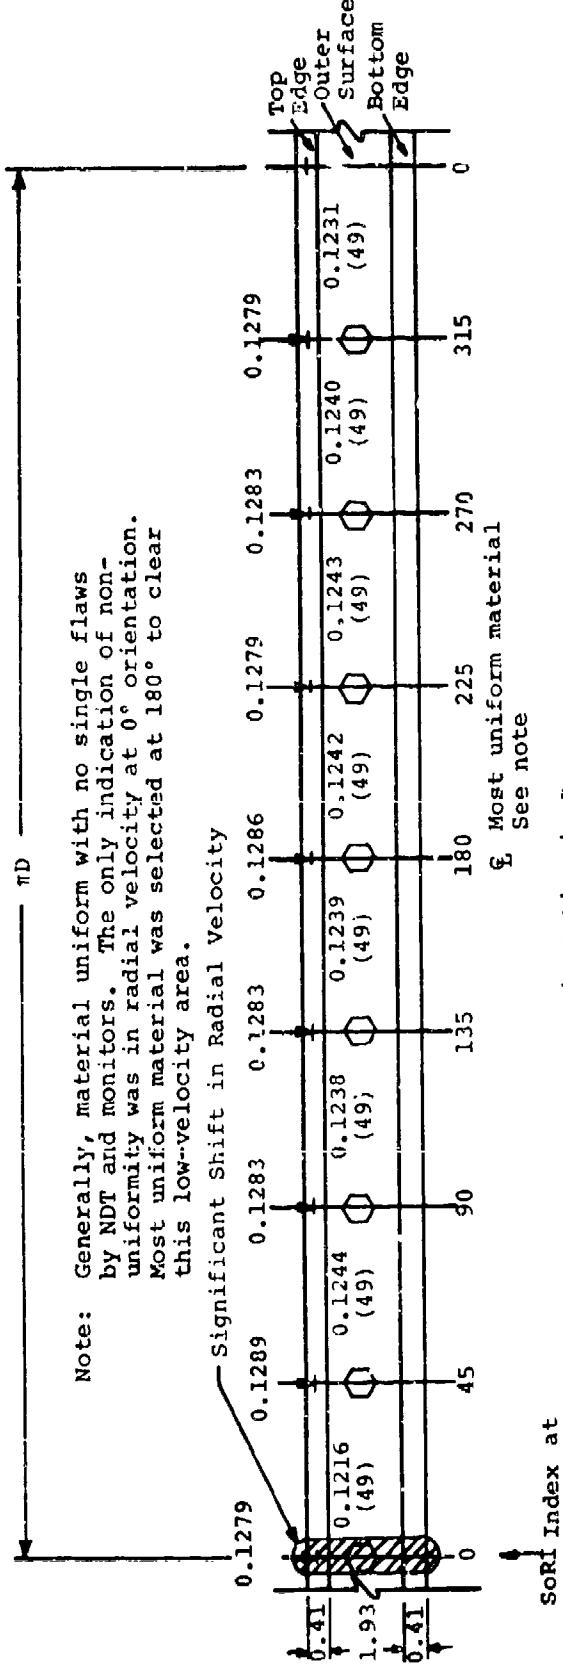
Figure 12. Sketch Showing Inspection Results on Ring 83301-305-4 from AVCO R6300

1. Radial velocity in in./ μ sec
(Relative radial transmission in added dB) - First Run
(Relative radial transmission in added dB) - Second Run
Higher attenuation readings correlate with lower attenuative material
2. Axial velocity in in./ μ sec
3. Visual inspection results - no single flaws
4. Penetrant inspection on edges using 2, 2, 4 - Trimethylpentane - no single flaws

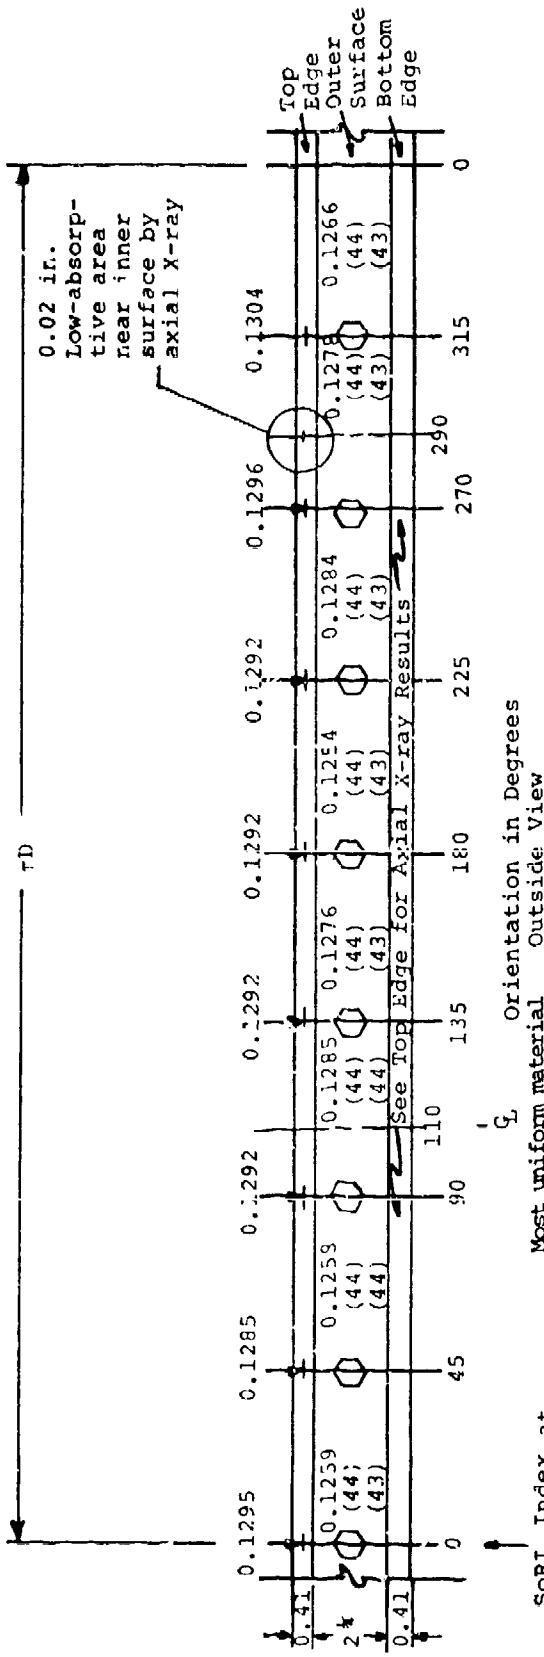
Figure 13. Sketch Showing Inspection Results on Ring 83301-305-1 from AVCO R6300

Some structural change was indicated in exposed Rings 83301-305-1 and 83301-400 by visual, X-ray, and liquid penetrant inspections. For 83301-305-1, the change was visually apparent matrix damage on the front face (outer surface) of the exposed area, Figure 14. Also, increased porosity to a depth of 100 mils on the rear face (inner surface) of the exposed zone was visually apparent. For 83301-400, the only change detected was increased porosity to a depth of 80 mils on the rear face (inner surface) of the exposed zone. No change was detected in Ring 83301-305-4.

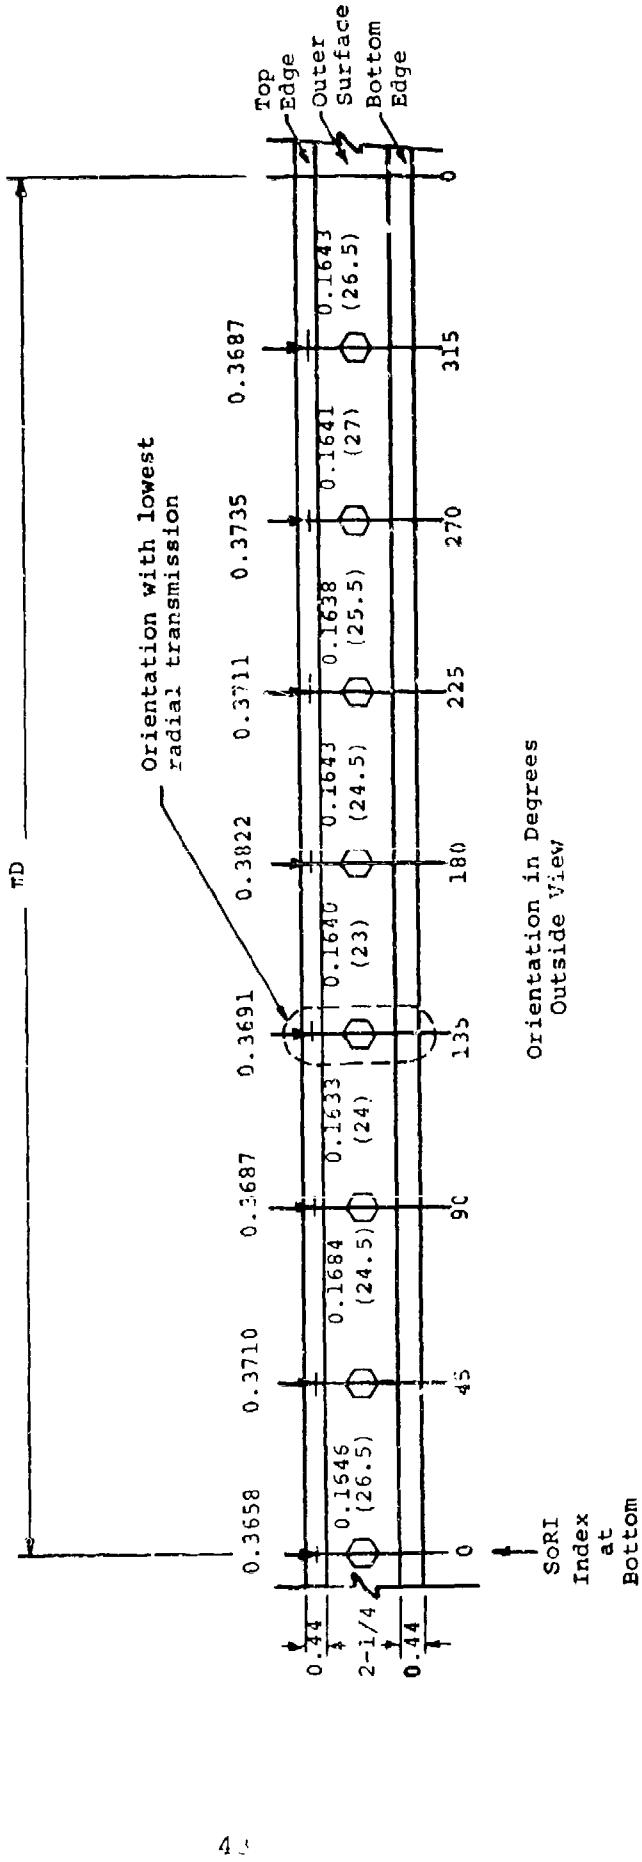
Figure 20. Sketch Showing Inspection Results on Ring : from AVCO 3DCP

1. \square Radial Velocity in in./usec (Average for two runs-Relative Radial transmission in added-dB)-Higher readings correlate lower material attenuation.
 2. + Axial Velocity in in./usec
 3. Penetrant (2,2,4-Trimethylpentane) not revealing
 4. Density = 1.415 gm/cm³
 5. Most uniform material G at 270°
- 0.8 in. long low-absorptive alignment.
by axial X-ray

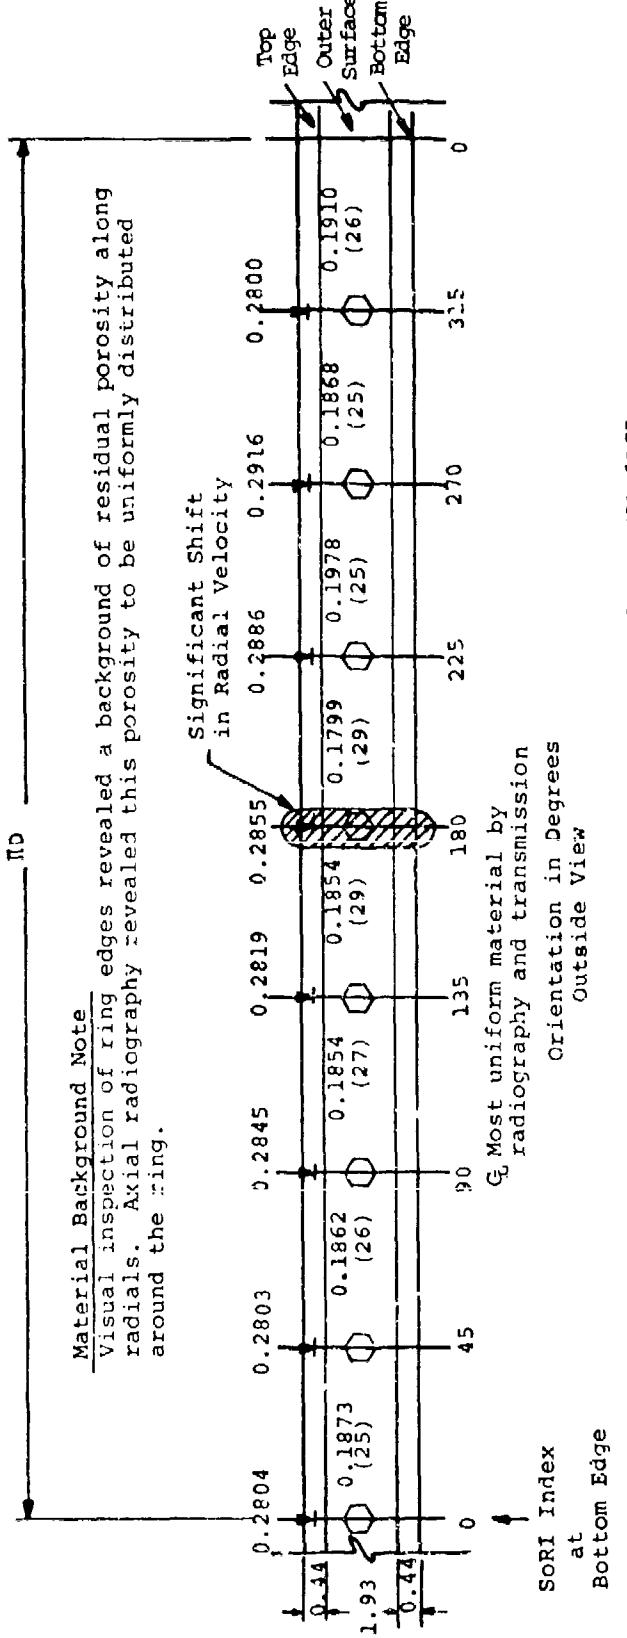
Figure 23. Sketch Showing Inspection Results on Ring 83301-202A from AVCO 3DCP

Radial Velocity in in./ μ sec
(Average relative radial transmission in added-dB) - Higher readings correlate lower material attenuation
2. + Axial Velocity in in./ μ sec
3. Visual and penetrant inspection revealed no single flaws
4. Density = 1.316 gm/cm³

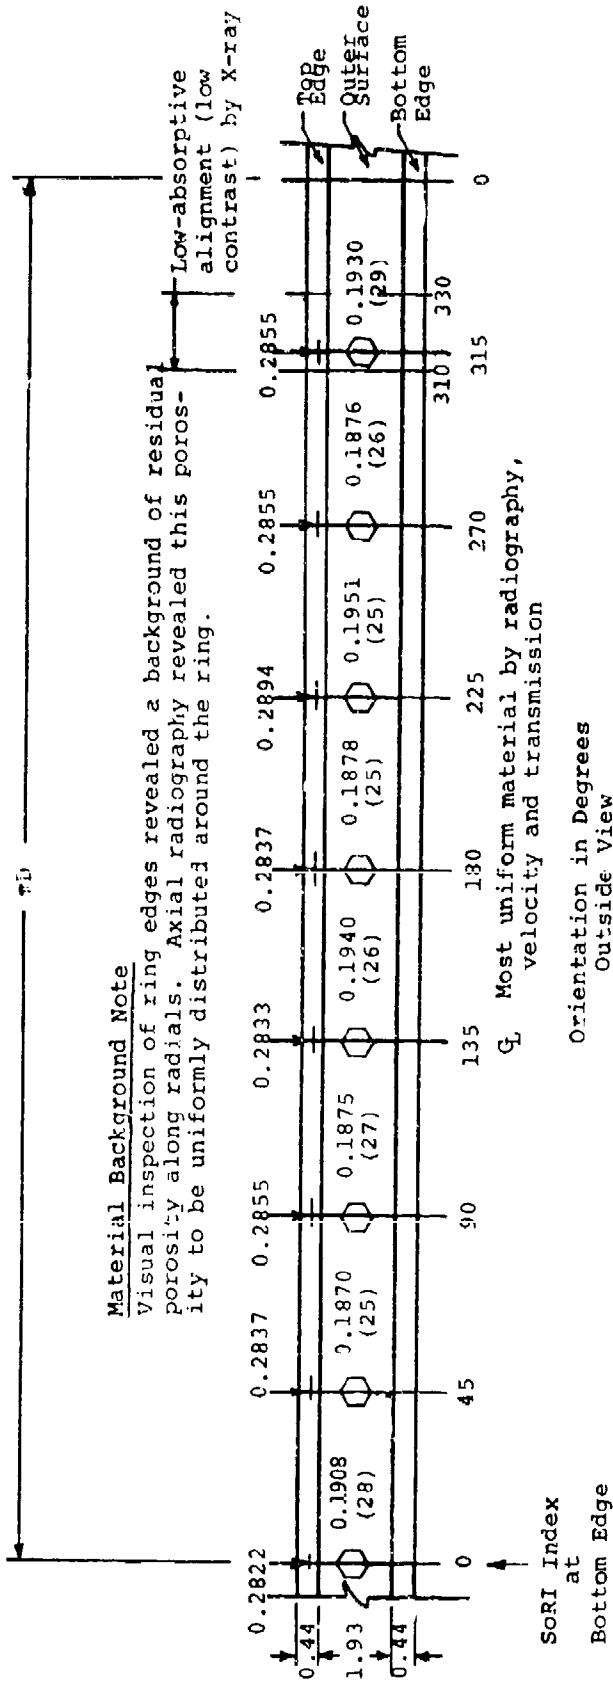
Figure 24. Sketch Showing Inspection Results on Ring 83301-305-2 from AVCO 3DCP

1. \odot Radial Velocity in in./ μ sec
(Average relative radial transmission in added-dB)-Higher readings correlate lower material attenuation
2. + Axial Velocity in in./ μ sec
3. Visual and penetrant inspection revealed no single flaws
4. Radiography revealed no single flaws - most uniform material at 90° and 180° orientation
5. Density = 1.321 gm/cm³

Material Background Note
Visual inspection of ring edges revealed a background of residual porosity along radials. Axial radiography revealed this porosity to be uniformly distributed around the ring.

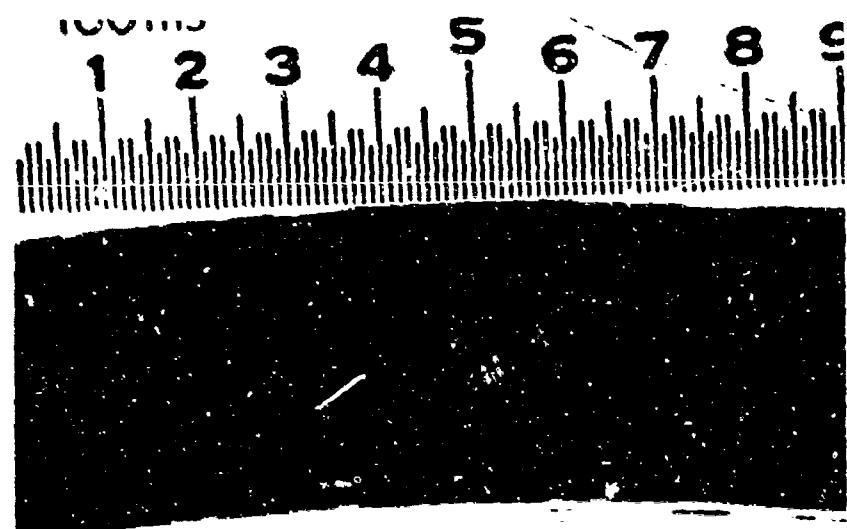
The material background was generally considered similar to AHP 3DC/QP material reported in AFML-TR-72-160. For Ring 3, the material had lower porosity and straighter circumferentials than the AHP material, Figure 26. For Rings 83301-202B and 83301-305-5, the material had an extremely high residual porosity along radials and between axials, Figure 27. Also, for these rings, missing pieces of axials and circumferentials from machined surfaces and residual porosity between radials and axials at the inner surface were typical of the material, Figures 26 and 27.

Extremely high
residual porosity
along radials and
between axials

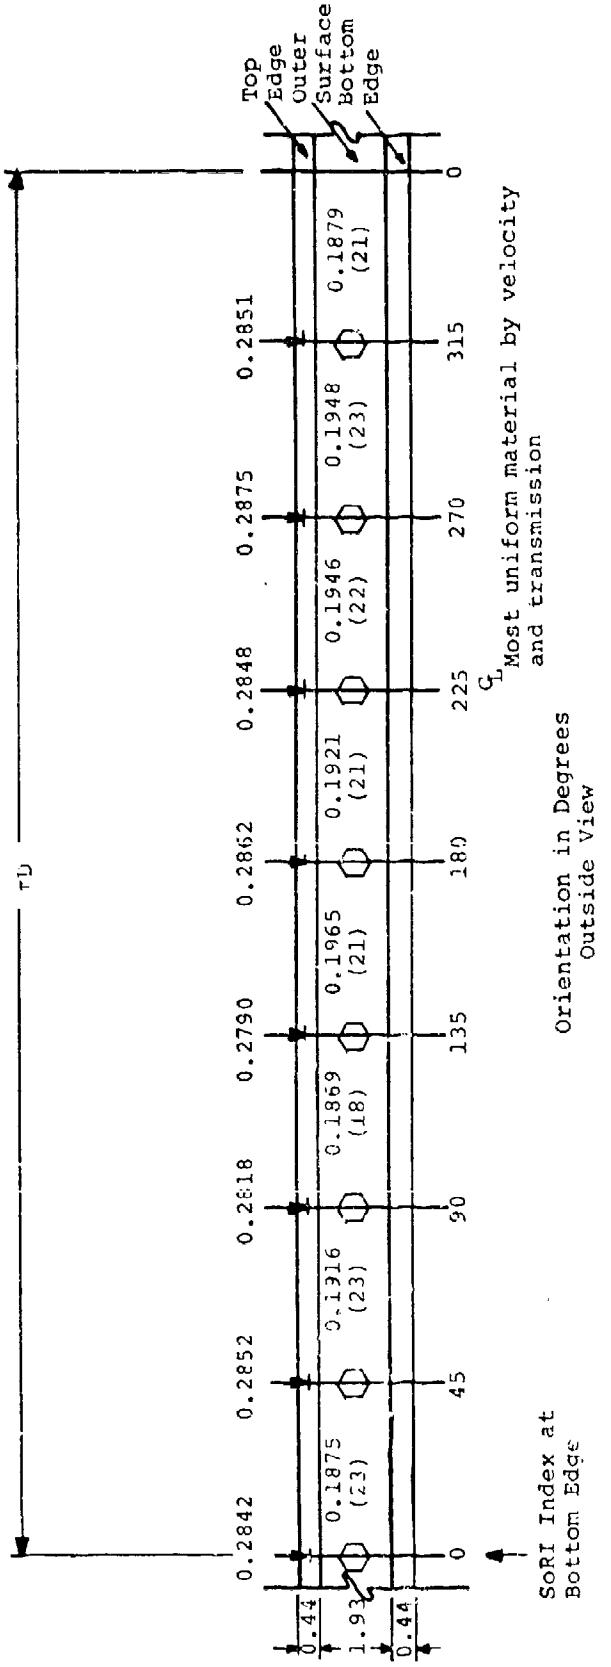
Figure 29. Sketch Showing Inspection Results on Ring 83301-305-5 from AVCO 3DCP/QP

1. ◊ Radial velocity in in./usec
(Relative radial transmission in added-dB)-Higher readings correlate lower material attenuation
2. + Axial velocity in in./usec
3. Visual and penetrant inspection revealed no single flaws
4. Radiography revealed uniform material with no single flaws
5. Density = 1.354 gm/cm³

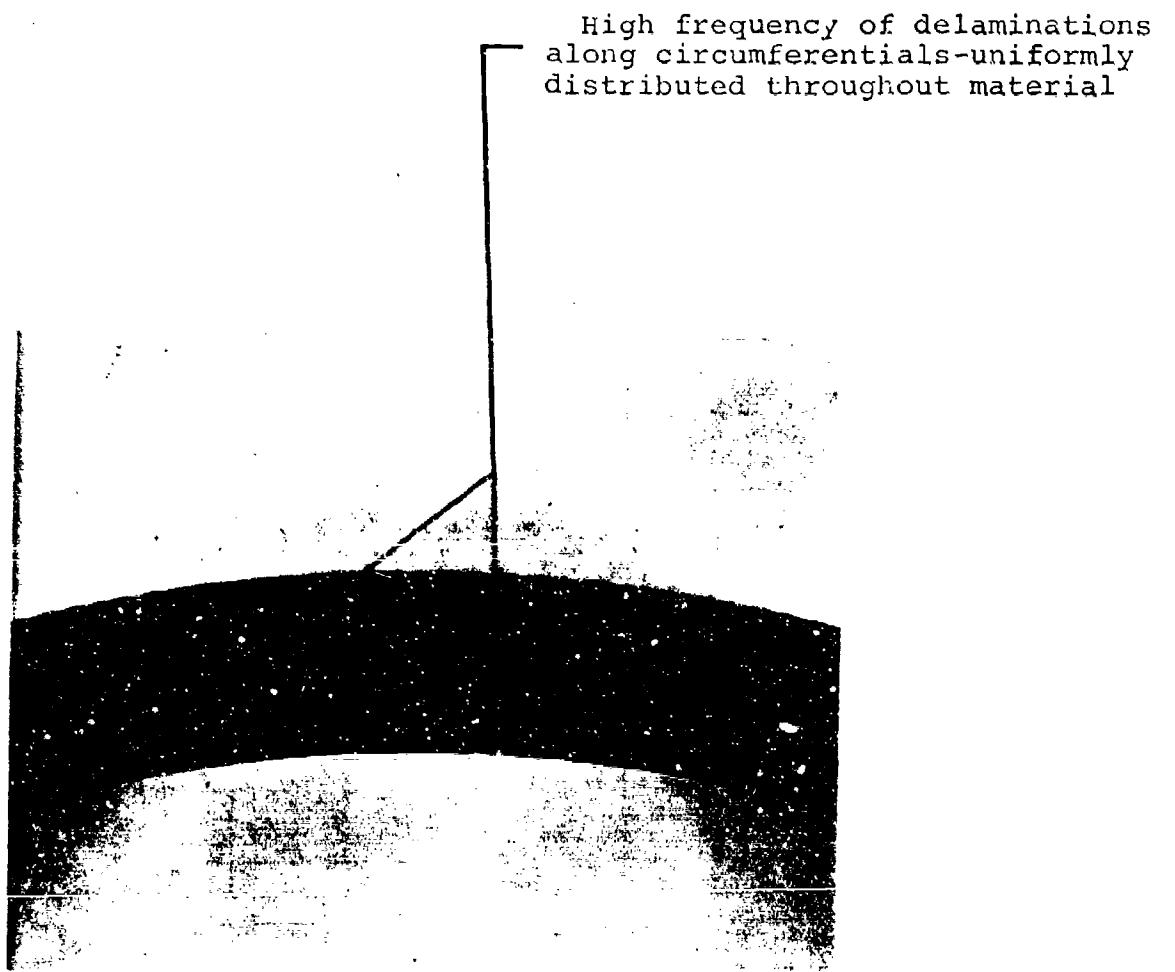
Figure 30. Photograph Showing Typical AVCO 3DCC

For background, the material was generally uniform, workman-like, and similar to AHP 3DCC material which was reported in AFML-TR-73-160. The exception was that the delams (also called debond and matrix rich areas) along the circumferentials were more frequent than for the AHP material, Figure 30. These delams were uniformly distributed throughout the material. Also, missing radials in machined edges were also typical of the material.

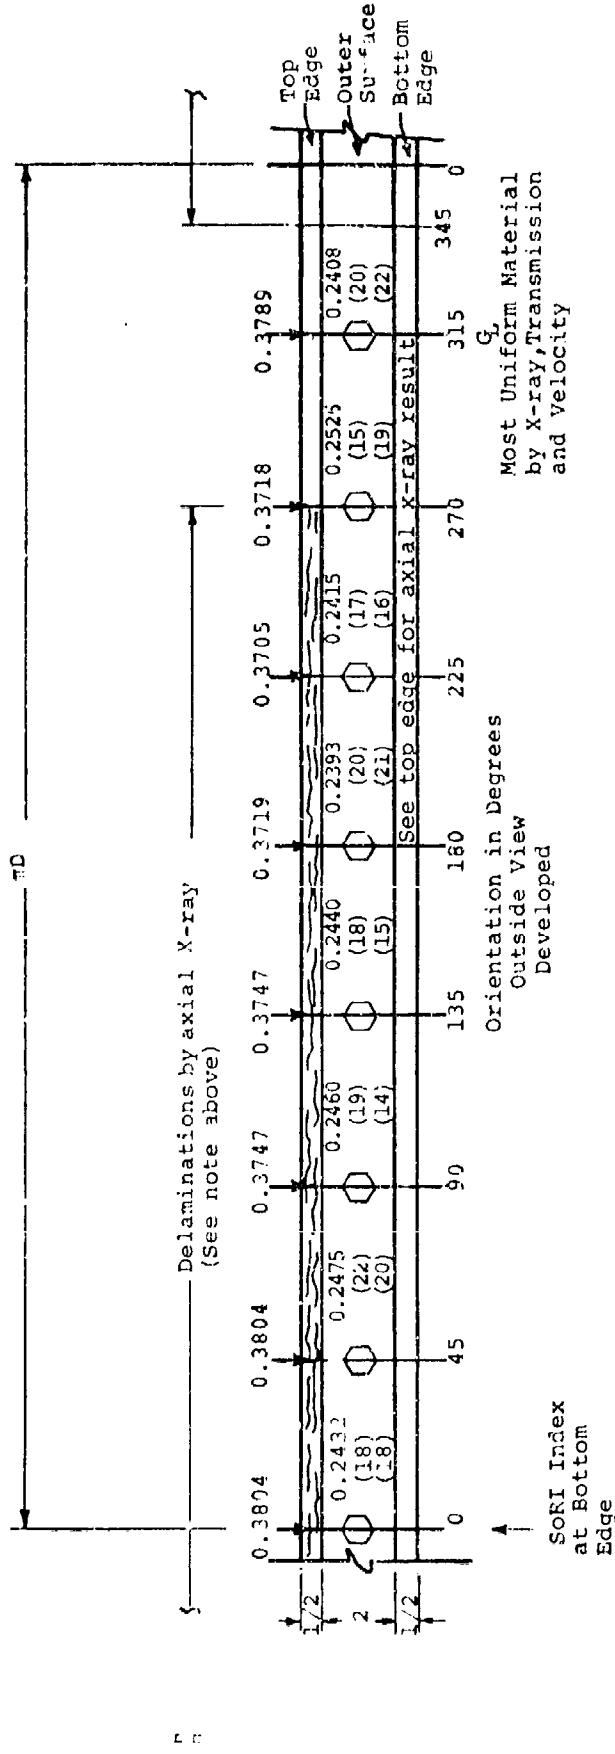
Figure 31. Sketch Showing Inspection Results on Ring 1109-35-2 from AVCO 3DCC

1. Radial velocity in in./usec
(Radial Ultrasonic transmission in added-dB) -First Run } Higher transmission readings correlate
(Radial Ultrasonic transmission in added-dB) -Second Run }
2. + Axial velocity in in./usec
3. Visual inspection results-no single flaws
4. Penetrant inspection on edges using 2,2,4 Trimethylpentane-no single flaws
5. This material had a high frequency of background circumferential delaminations extending across radials in the axial and circumferential directions by vision.
6. Bulk density = 1.645 gm/cm³

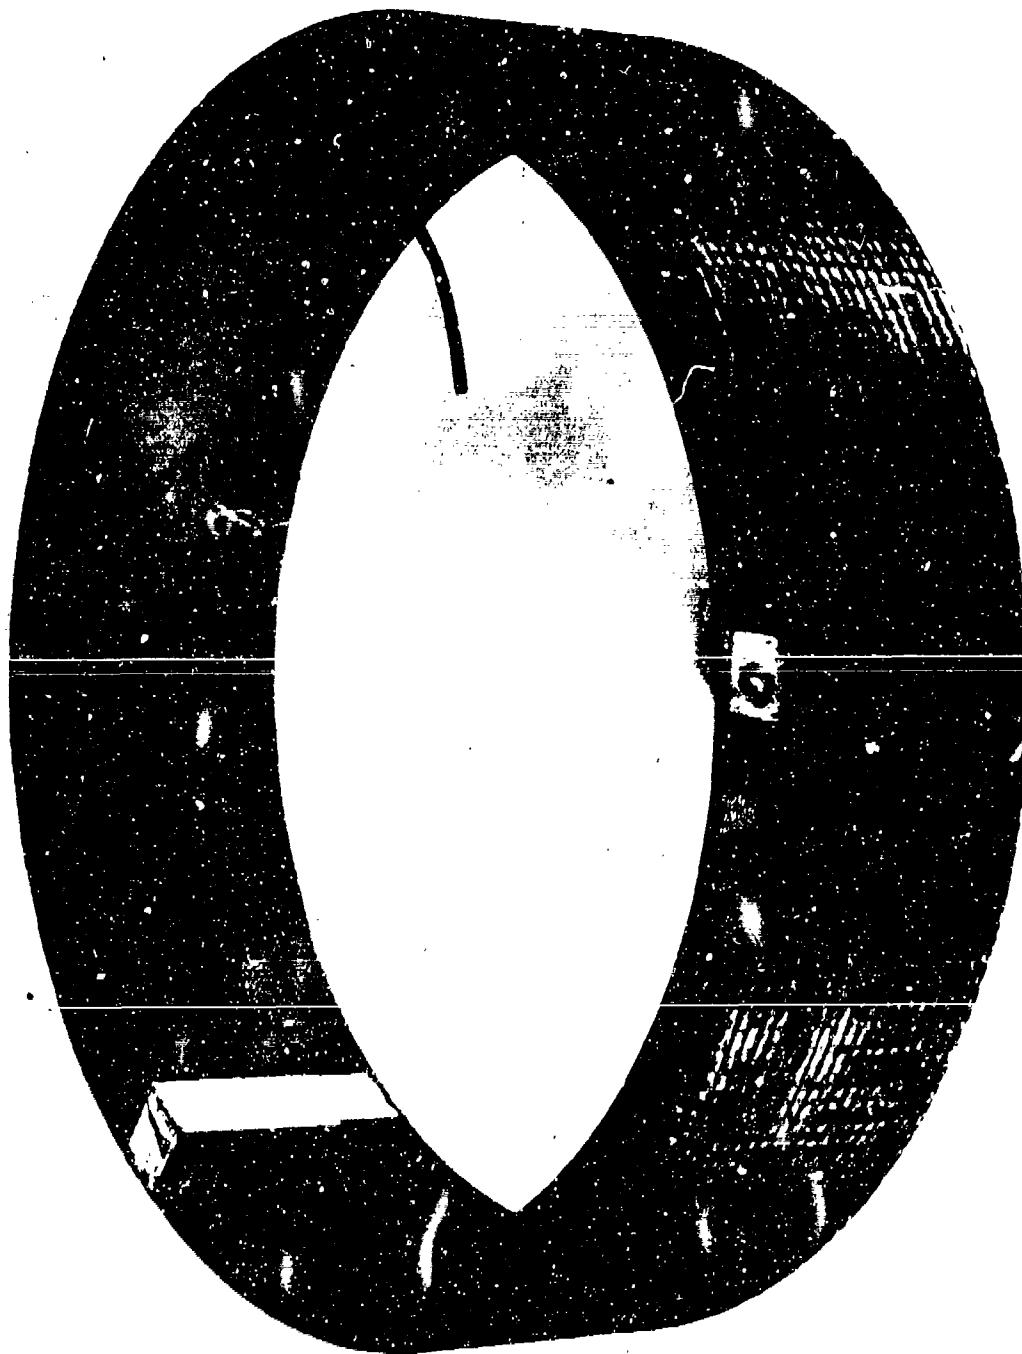
Figure 33. Photographs Showing As-Received Ring 1109-35-2 from AVCO 3bdc
After Exposure

Structural change was visually apparent in both rings. Photographs showing the as-received rings are given in Figures 33 and 34. Generally, for both rings, the change consisted of raised or recessed and missing radials, cracking along local preexisting circumferential delams completely around the ring,

spalled sections of matrix and circumferential reinforcement (circs) over radials in edges, yarn lift from the front face, and discolorations (dark) on the front face. These and other changes are detailed in Table 5 and Figures 35 and 36. Absorption of trimethylpentane into edges of both exposed rings was higher in the exposed zone than out of the exposed zone. The only change indicated by axial X-ray was a 1-1/2-inch long circumferential low-absorptive alignment at 315°.

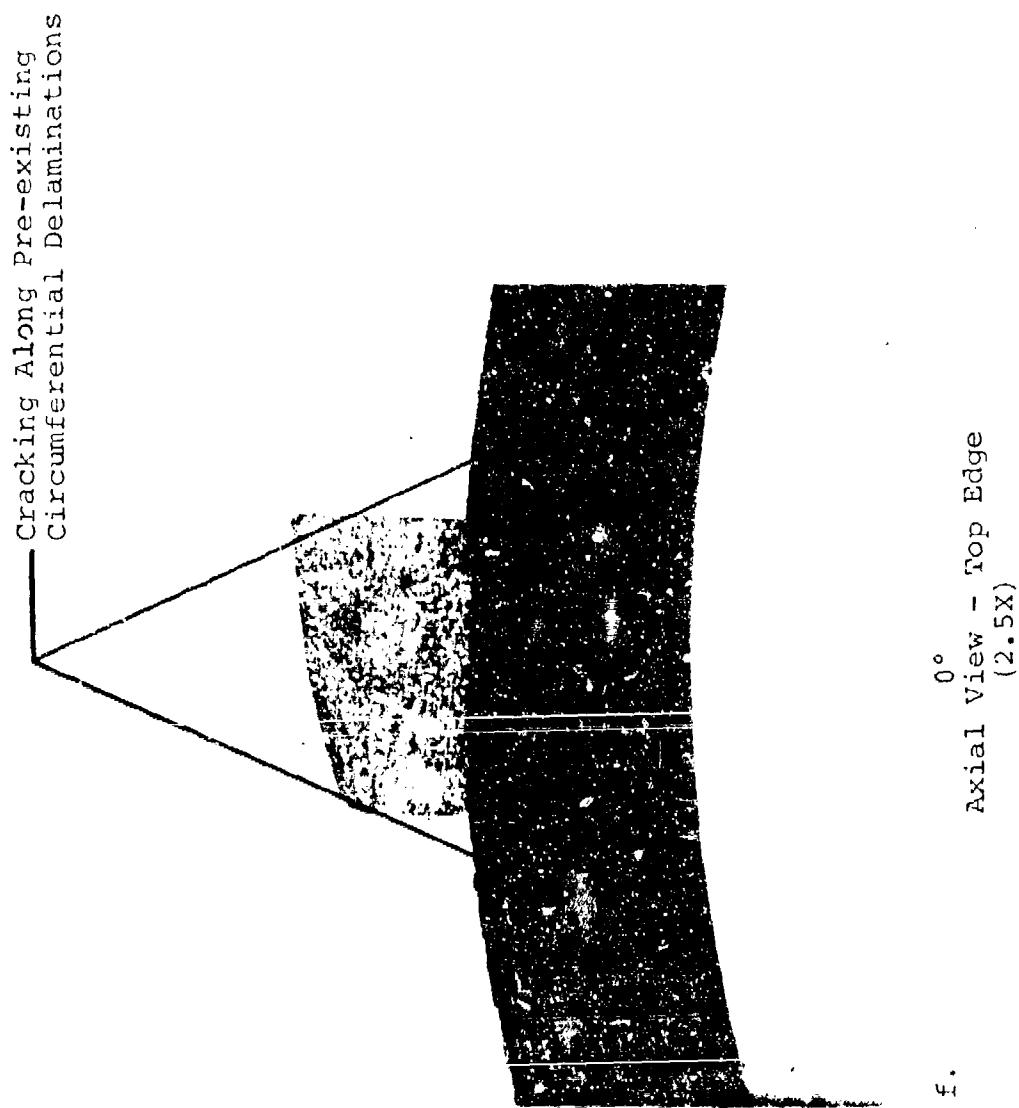
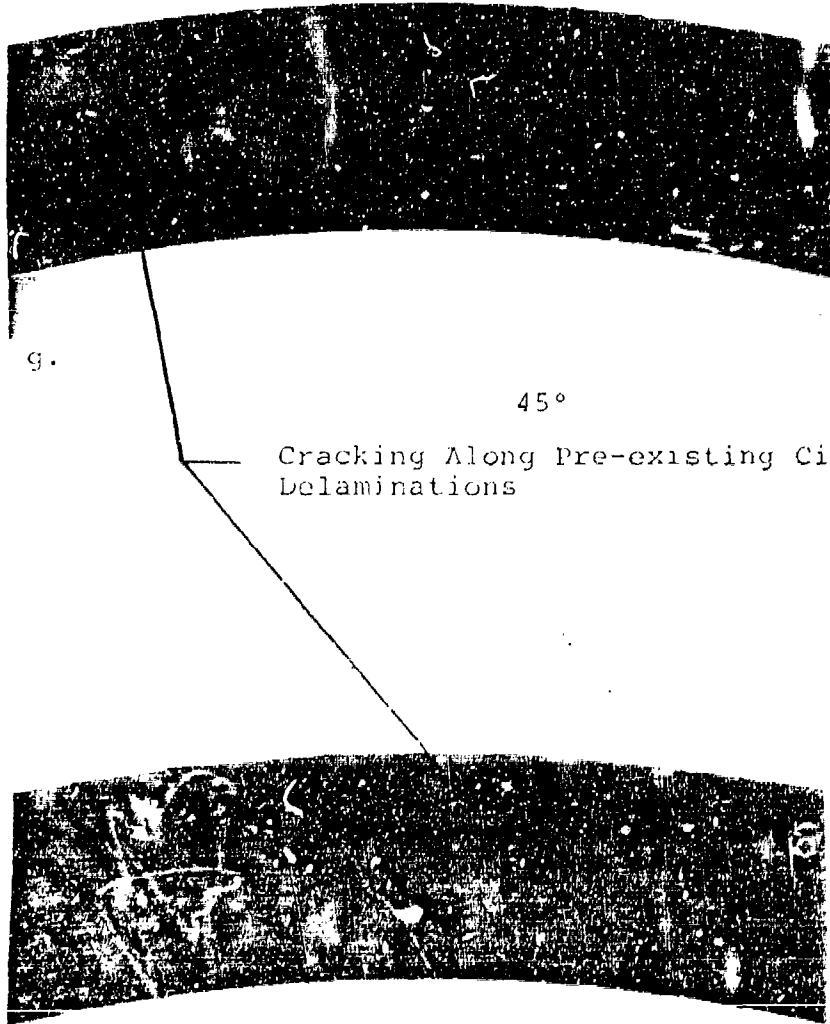
Figure 36. Photographs Showing Structural
Change After Exposure in Ring
1109 - 35-3 from AVCO 3DCC

Cracking Along Pre-existing Circumferential
Delaminations

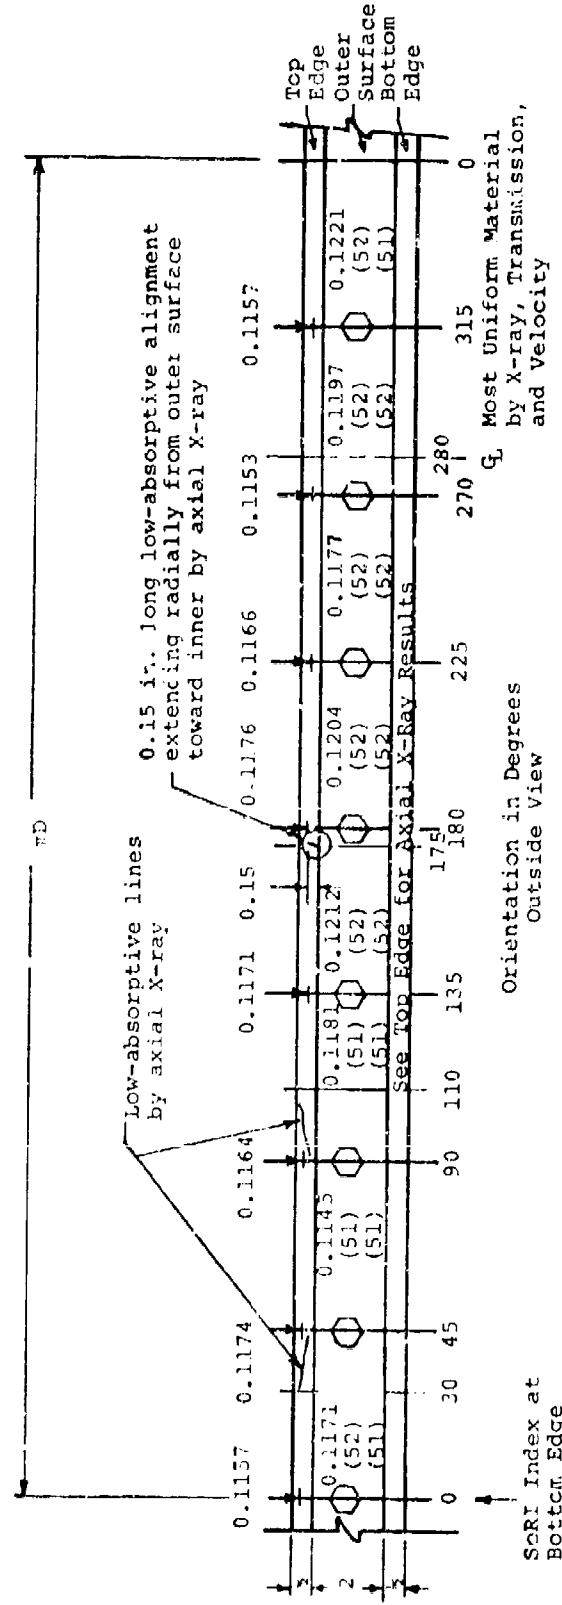
Figure 38. Sketch Showing Inspection Results on Ring 9N-2 from Sandia Felt CC

Radial velocity in in./usec
(Relative radial transmission in added-dB) - First Run } Higher transmission readings correlate
(Relative radial transmission in added-dB) - Second Run } lower attenuative material
2. Axial velocity in in./usec
3. Visual inspection results - no single flaws
4. Penetrant inspection on edges using 2, 2, 4-trimethylpentane - no single flaws

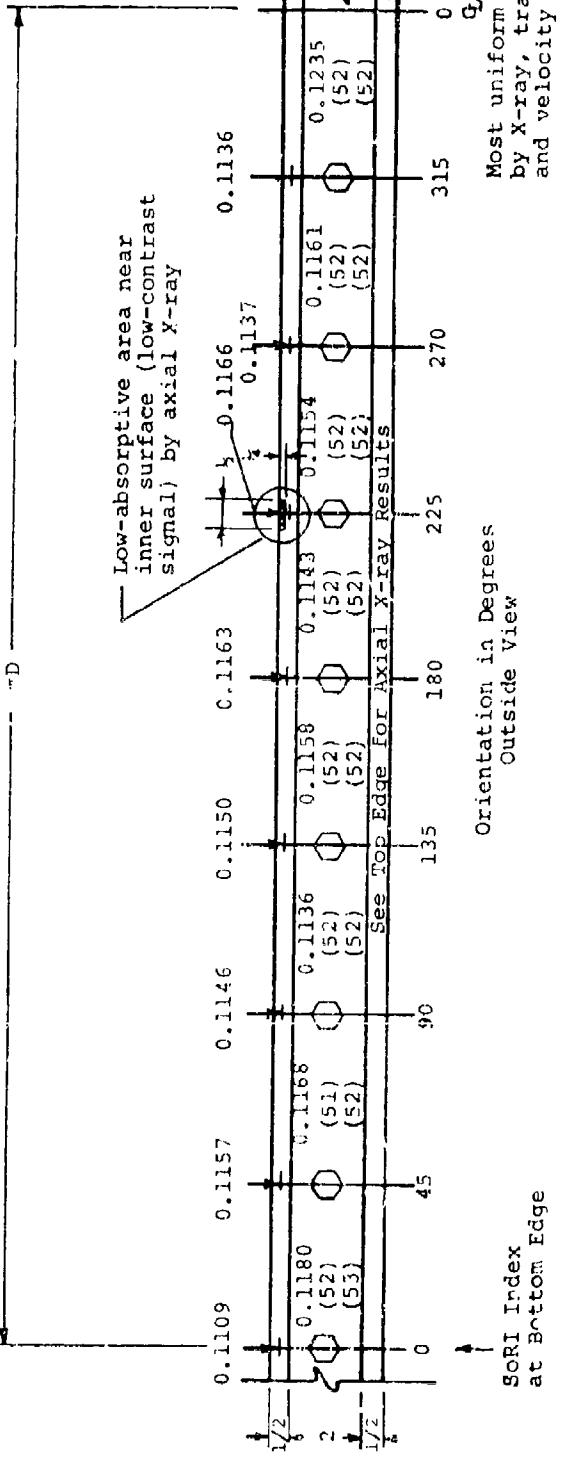
Figure 39. Sketch Showing Inspection Results on Ring 9P-2 from Sandia Felt CC

Radial Velocity in in./usec
(Relative radial transmission in added-dB) - 1st Run
(Relative radial transmission in added-dB) - 2nd Run
2. + Axial velocity in in./usec
3. Visual inspection results - no single flaws
4. Penetrant inspection on edges using 2, 2, 4-Triethylpentane - no single flaws

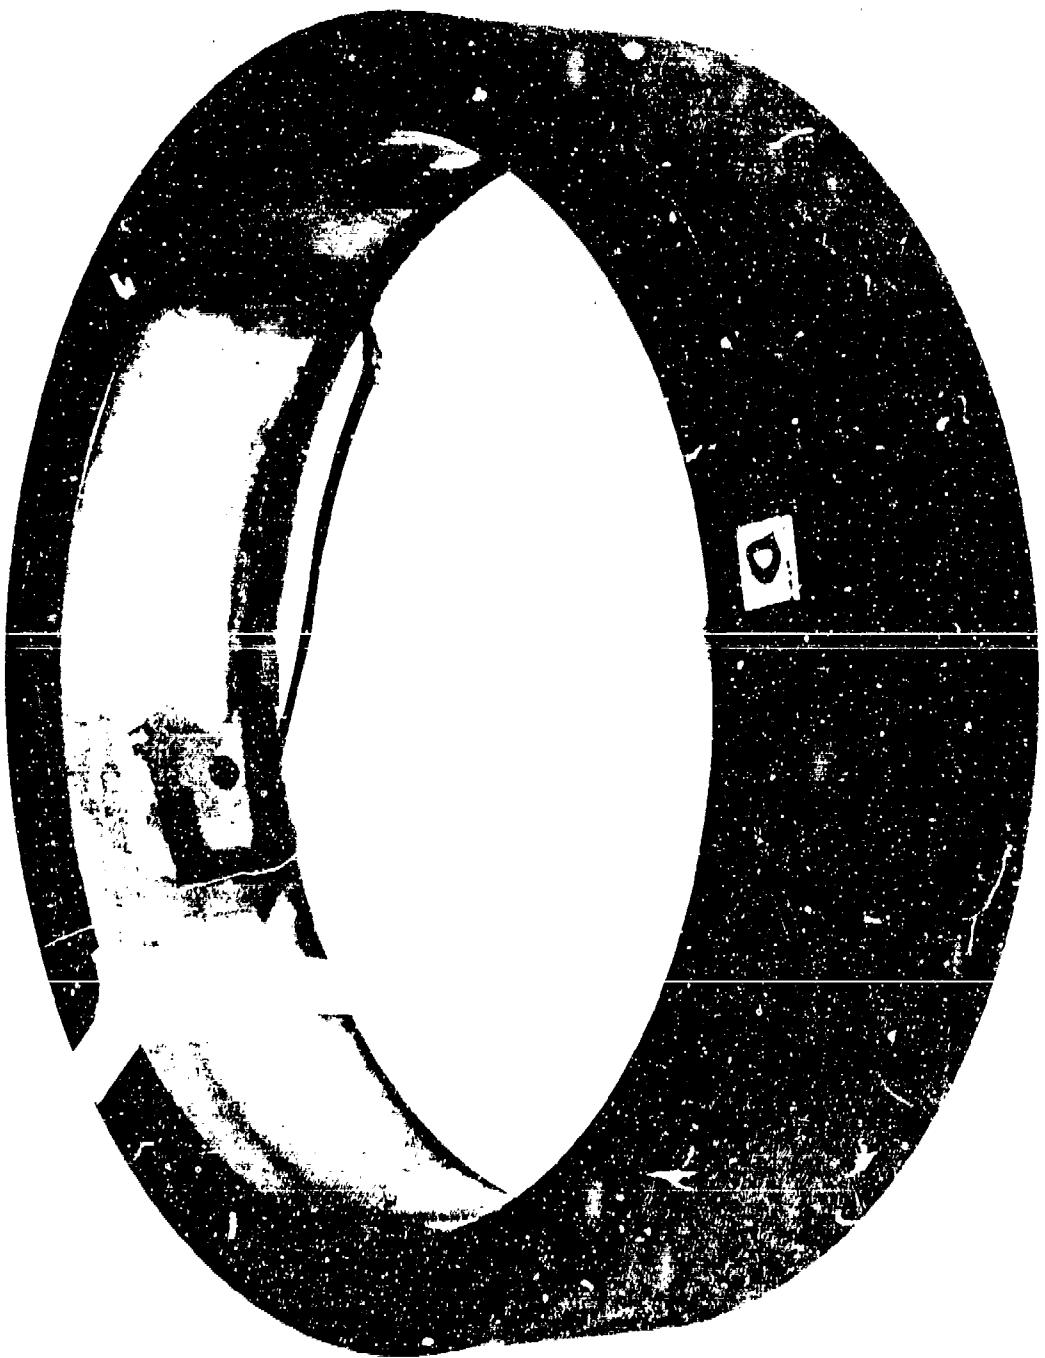
Figure 40. Photographs Showing As-Received Ring 9N-2 from Sandia Felt CC
After Exposure

No really significant structural change such as cracking was detected in these two rings. Photographs showing the rings as-received are given in Figures 40 and 41. For 9N-2, the only changes or noteworthy observations were that the exposed-zone segment of the bottom edge was slightly more porous, Figure 42a, and the exposure-zone outer surface (front face) was slightly discolored (dark) and rougher in texture, Figure 42b and c. For 9P-2, change and noteworthy observations were discoloration (dark) on top edge, 80 mil chip in top outer edge at 315°, higher porosity in exposure-zone of bottom edge, 20-mil voids in bottom edge at 240 - 255° and 270°, and material removal and discoloration in exposure-zone front face. These changes are detailed in Table 6 and depicted in Figure 43. Axial X-ray and liquid penetrant inspection did not reveal any structural change in these rings.

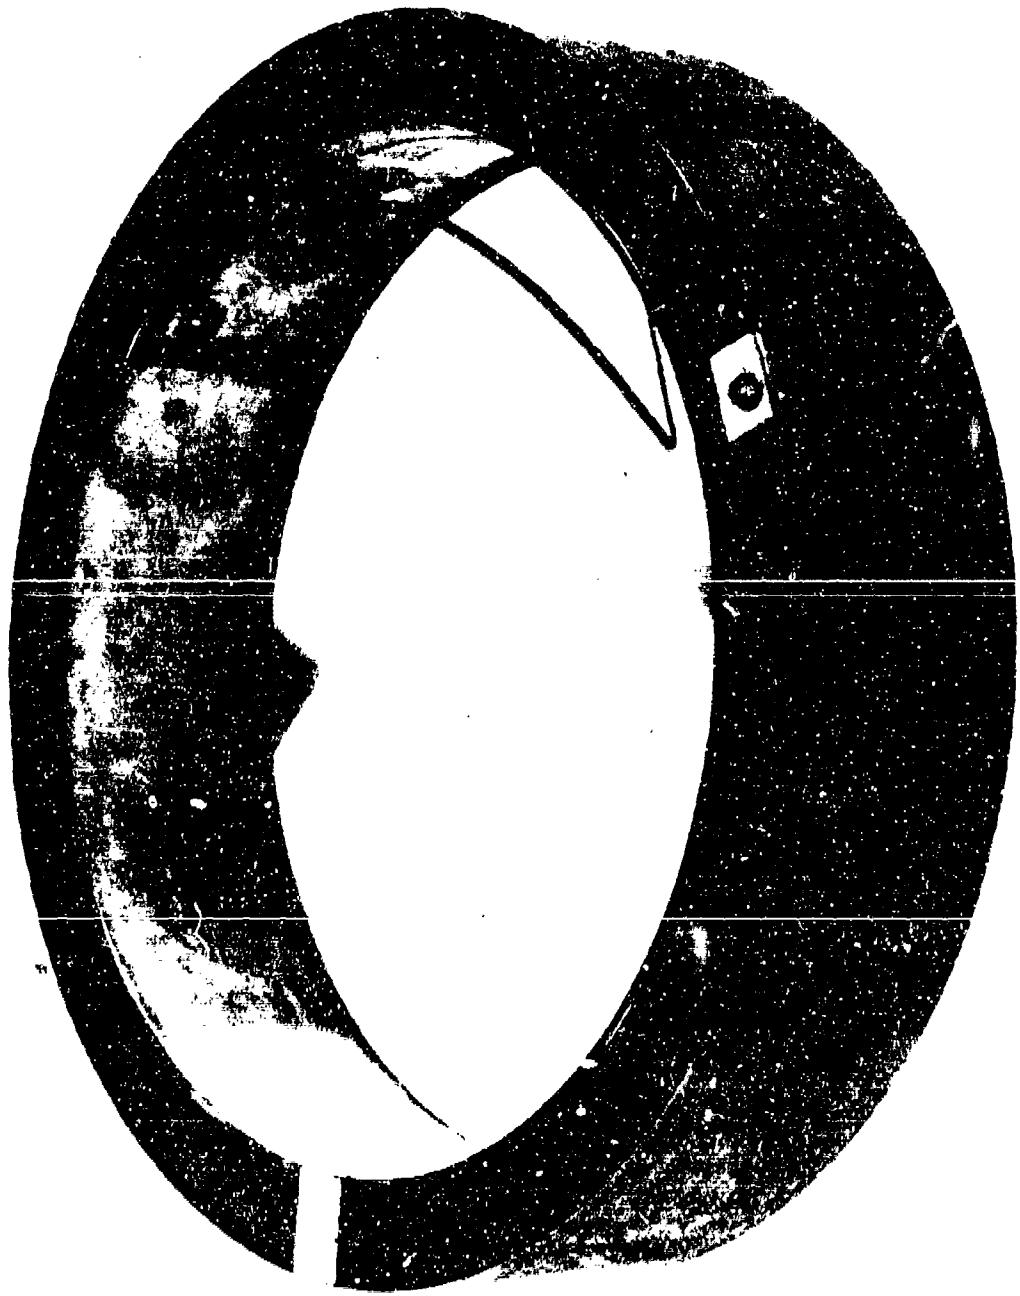
Figure 41. Photograph Showing As-Received Ring 9P-2 from Sandia Felt CC
After Exposure

Note: Bottom edge was slightly more porous at 275-0-45° location.
